Green Infrastructure Rapid Assessment Plan Tufa Glen Creek Watershed

May 2013

**The Stormwater Coalition
of Monroe County and
Monroe County
Department of
Environmental Services**

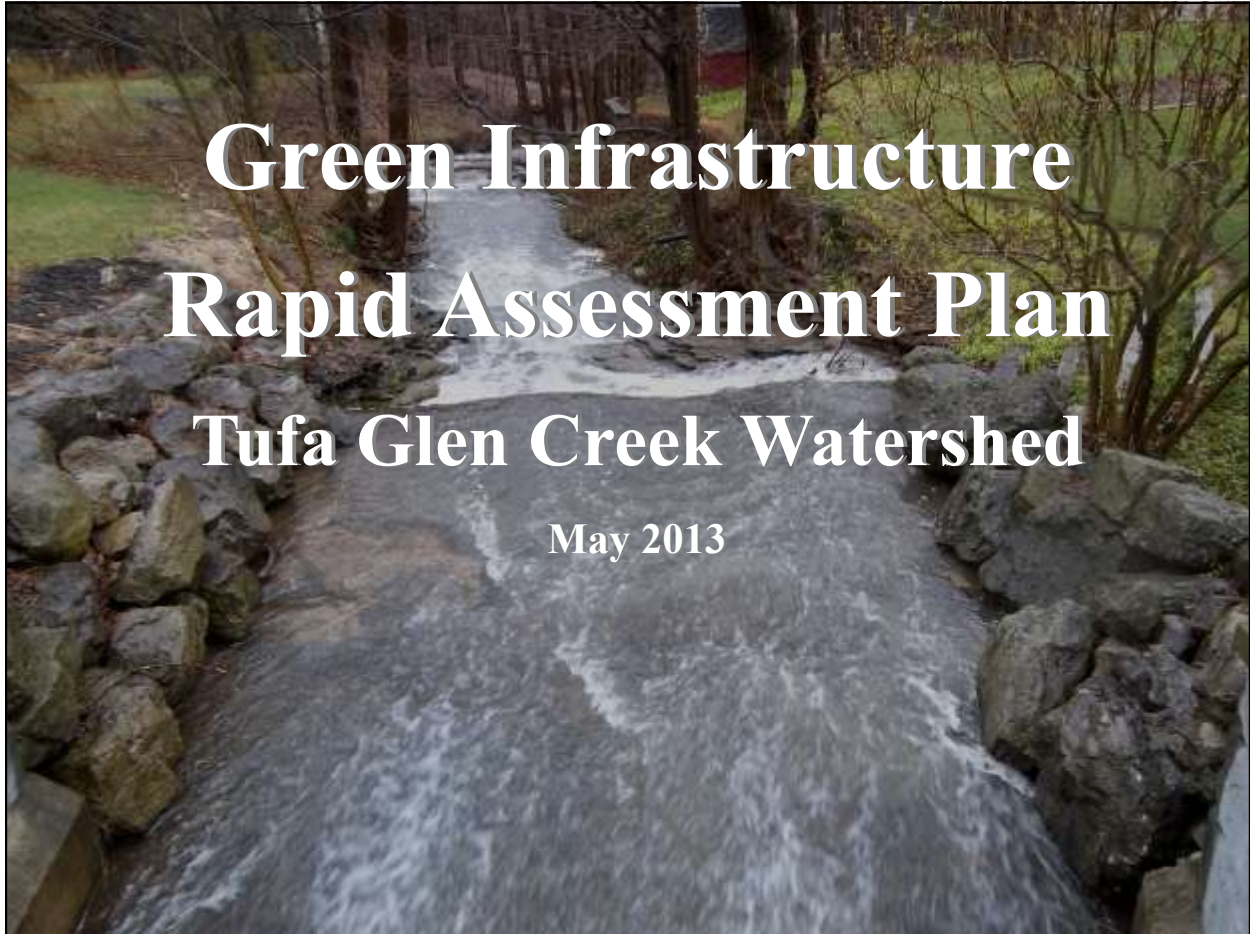
Cover Photo: Upper - Looking downstream at Creek Street; Lower - looking upstream at Creek Street

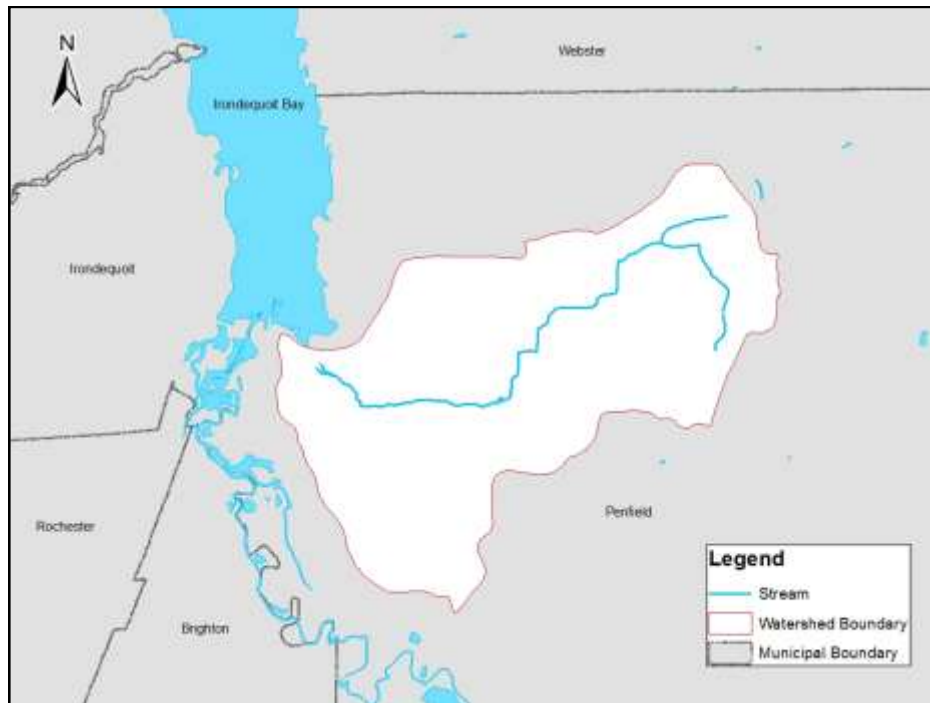
Figure 1: Tufa Glen Creek Watershed.

The entire 1900 acre Tufa Glen Creek watershed lies in the Town of Penfield (Figure 1). The creek's headwaters are East of Five Mile Line Road and south of Scribner Road in the Winchester Woods Subdivision. The main land use throughout the watershed is residential with a small agricultural area in the northeast (Figure 2). Table 1 shows key watershed characteristics.

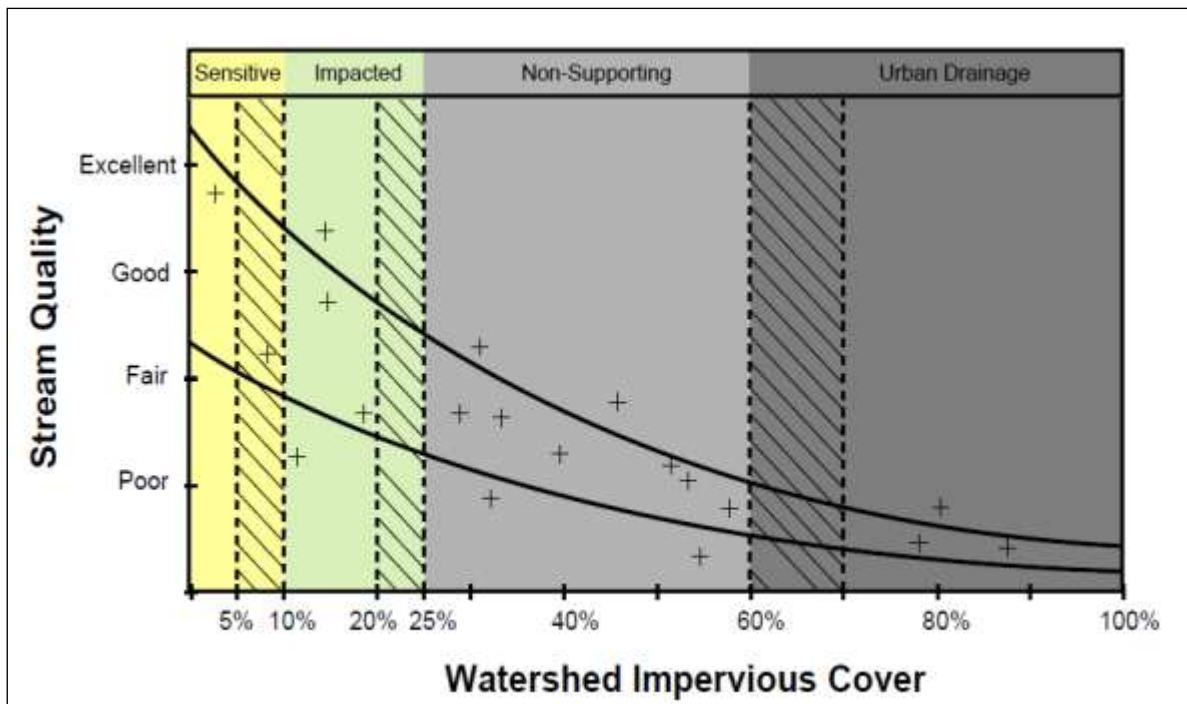
Figure 3. Impervious Cover Model

1.4.2 Impervious Cover Analysis The Center for Watershed Protection created the “Impervious Cover Model” (ICM) to predict a typical stream’s health using the relationship between subwatershed impervious cover and stream quality indicators and has been confirmed by nearly 60 peer-reviewed stream research studies (Figure 3) . The ICM shows that stream quality decline becomes evident when the watershed impervious cover exceeds ten percent. Tuffa Glen has an average of 22 percent impervious cover placing stream quality somewhere between poor and good and impacted aquatic life. Based on current zoning, future impervious cover (over the next 20 years) will increase by 4 percent.

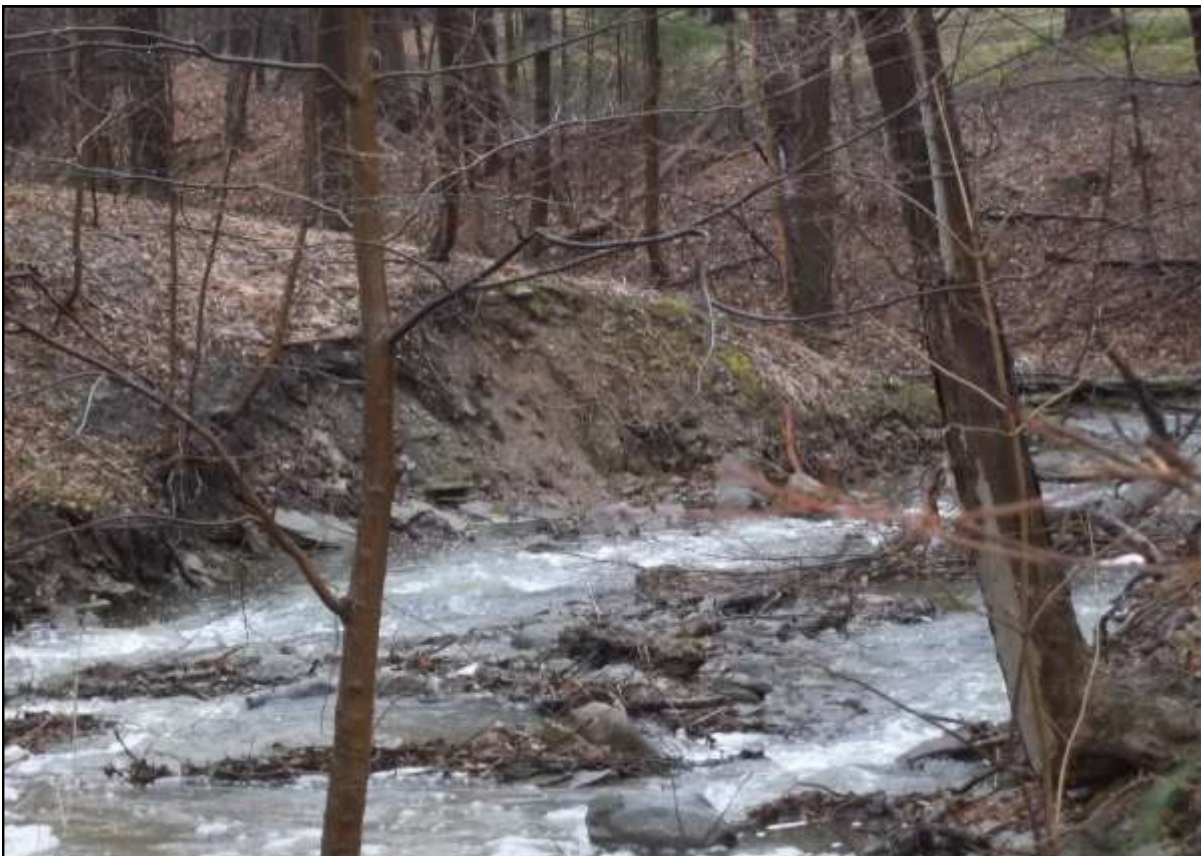
Figure 4. Eroded Streambank downstream of Creek Street on Tufa Glen

1.4.4 Streambank Erosion There were no reported erosion sites on Tufa GlenCreek from assessments done by the Monroe County Soil & Water Conservation District in 2001. However, there is extensive lengths of eroded stream bank in the lower segment as the Creek falls approximately 100 feet in elevation from Creek Street to Irondequoit Bay through highly erodible glacial soils (Figure 4).

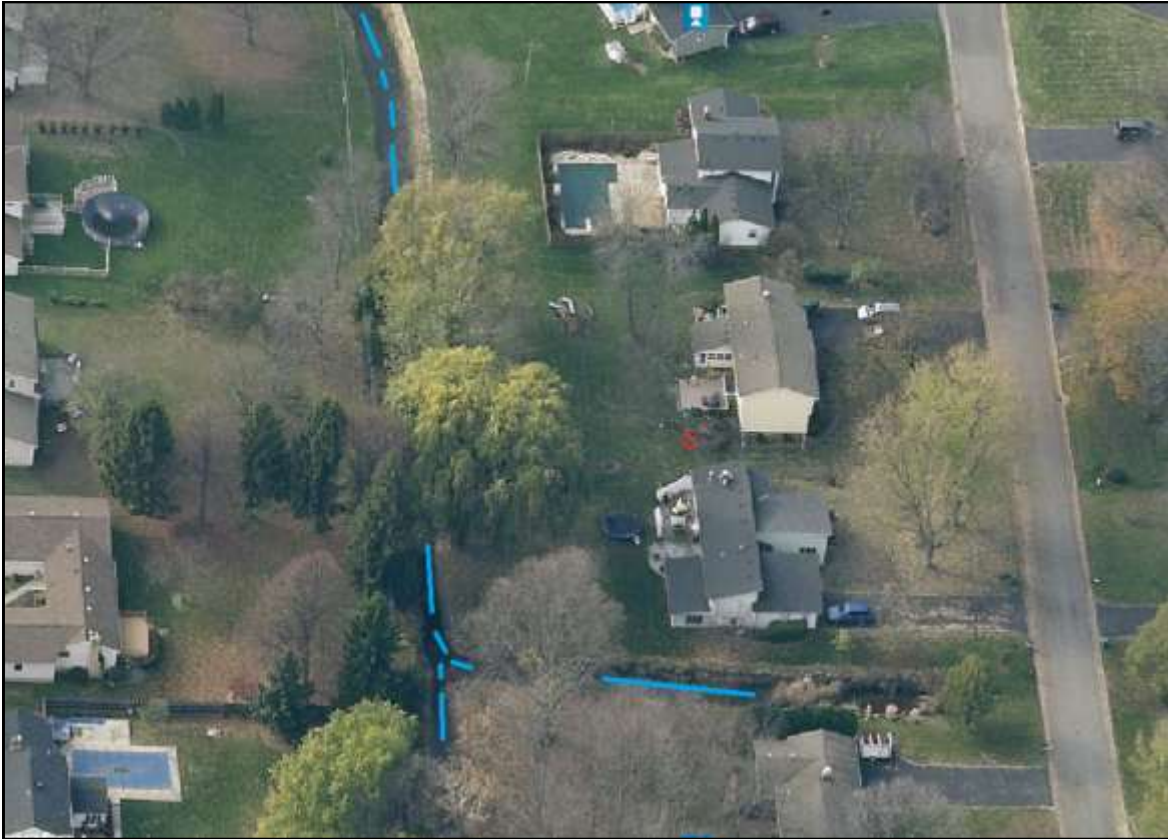
Figure 5. Tufa Glen Creek (blue dashed line) rock-lined and channelized

Staff at the Town of Penfield found no recent reports of erosion complaints in the upper watershed however, as the stream has been channelized and heavily armored where it flows through residential subdivisions built in the 1960's and 70's (Figure 5).

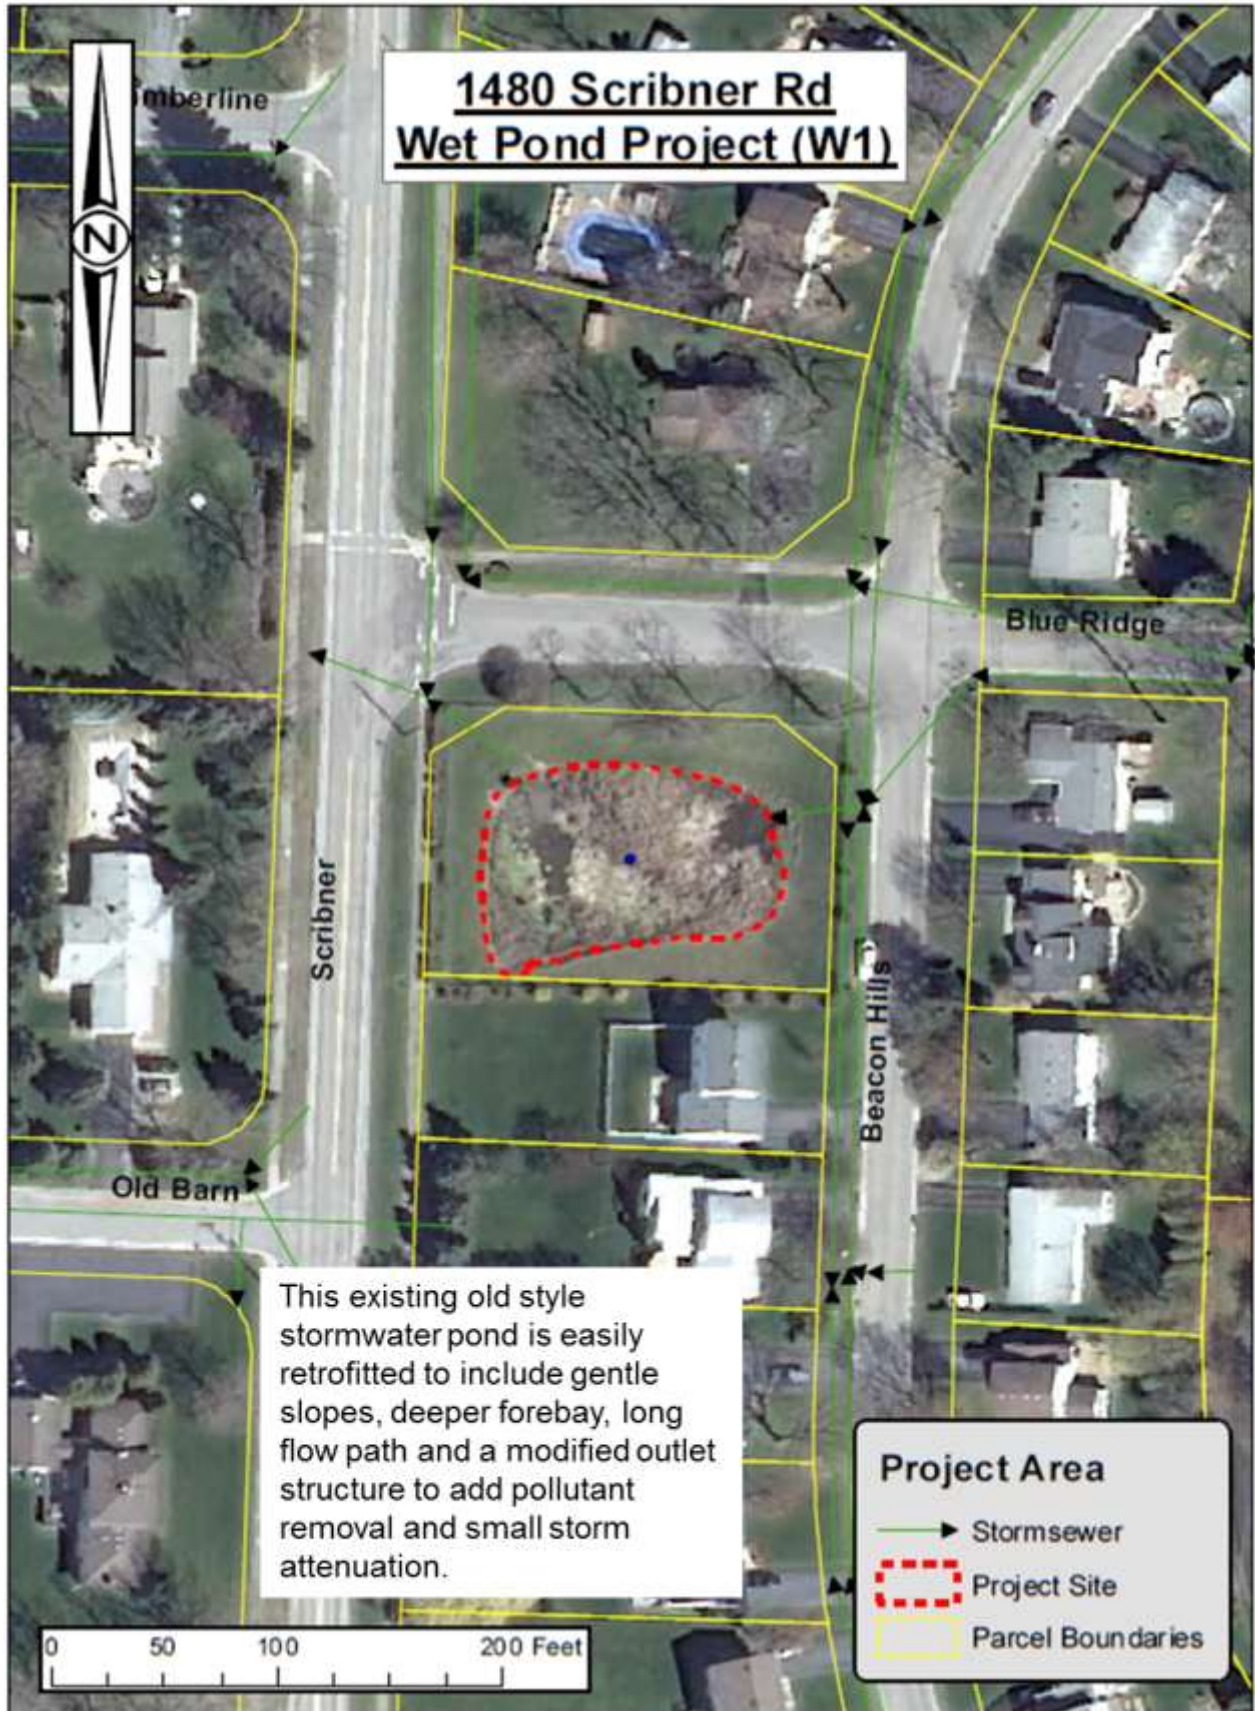
Belvista Neighborhood Green Infrastructure (N2)

This neighborhood was built in the 1960's before stormwater facilities were required so stormwater flows off this 113 lot residential subdivision untreated to Tufa Glen Creek. GI retrofits would be installed to capture roof runoff such as dry wells, vegetated filters, rain gardens and or rain barrels in order to increase water quality, flood storage, and community aesthetics.
