# Shipbuilders Creek Stormwater Assessment and Action Plan

Monroe County  
Department of Environmental Services  
444 E. Henrietta Rd.  
Rochester, NY. 14623

Shipbuilders Creek Stormwater Assessment and Action Plan is a  
Pilot plan of the Monroe County Stormwater Action Plan

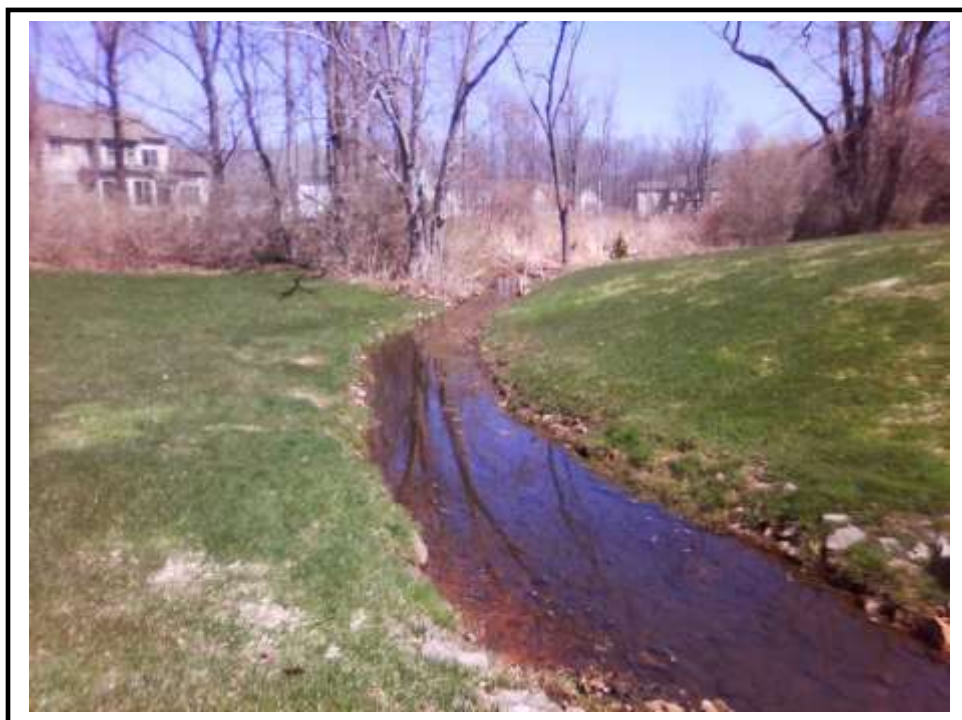
Figure E. 2 Stream Reach with no Stream Buffer

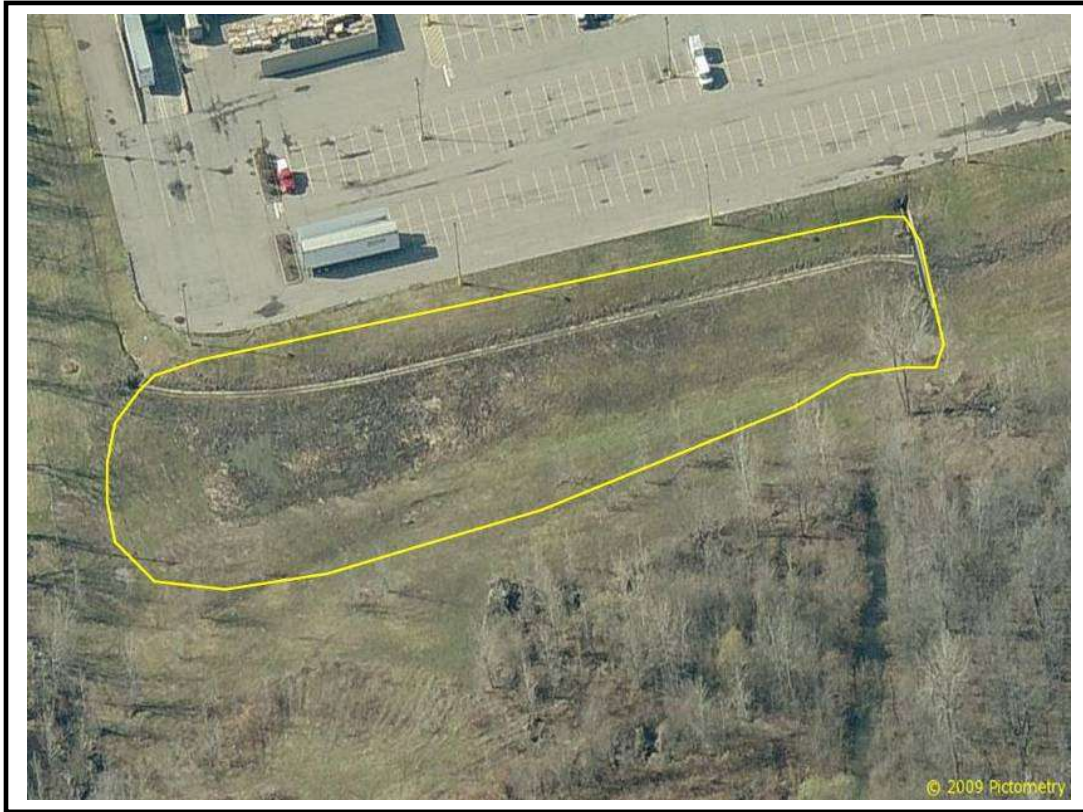
Figure E.3 Candidate Site - Upgrade Conventional Stormwater Pond

Figure E3 shows an existing dry basin “pond” with a concrete channel for flow conveyance. The dry pond provides storage for large storm events but small events typically stay in the channel and are conveyed downstream. Upgrades to existing stormwater ponds can involve removing existing concrete channels to allow for greater infiltration and water quality treatment for small events. These types of restoration projects have been shown to have the best cost-benefit.

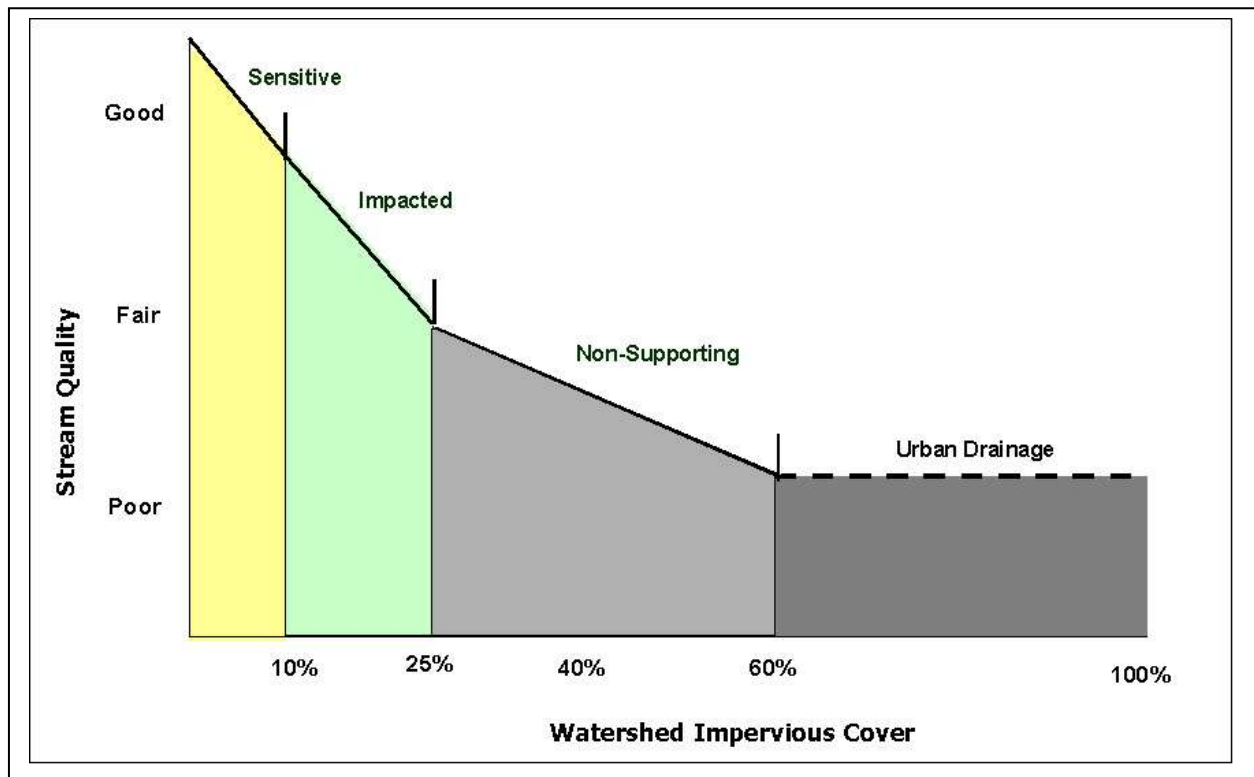
Figure 4. The Center for Watershed Protection Impervious Cover Model

shown that the amount of impervious cover within a watershed can be directly linked to the health of its receiving stream. From this research, the Center for Watershed Protection created the “Impervious Cover Model” (ICM). The ICM is best illustrated by a simple graph with the percentage of impervious cover in a watershed plotted against stream health. The horizontal scale of the graph divides impervious cover percentage into four ranges that correspond to four levels of stream water quality. As shown in Figure 4, the model predicts that most stream quality indicators decline when watershed impervious cover exceeds ten percent, with severe degradation expected beyond 25 percent.

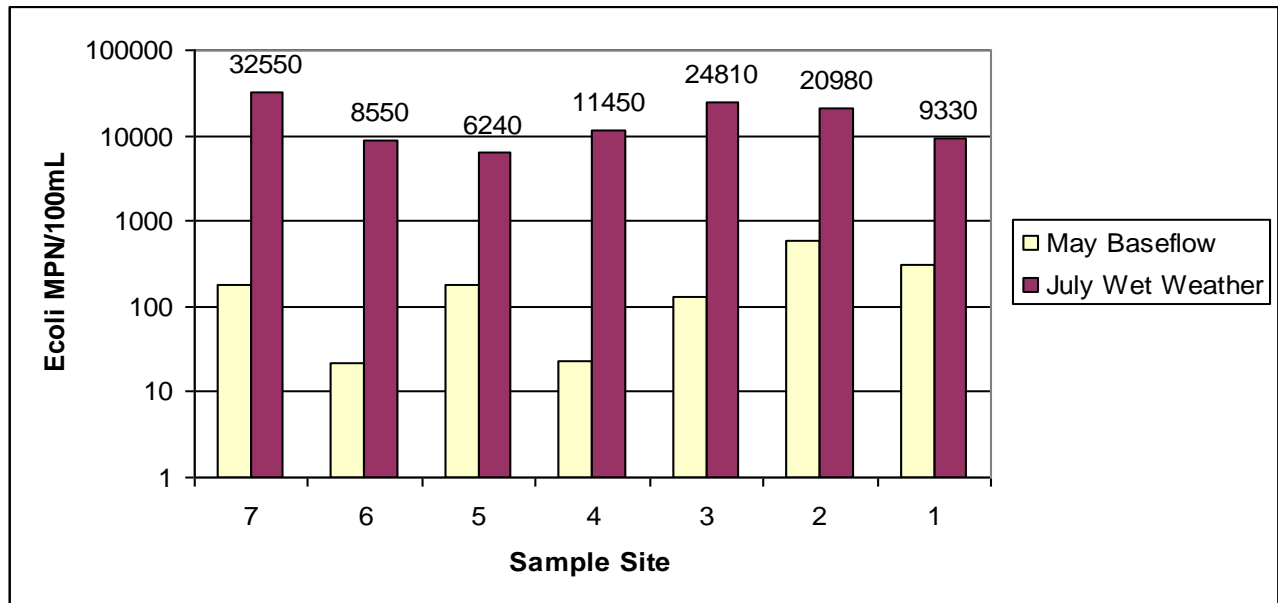
Figure 9. Comparison of baseflow and wet weather E. coli results

As expected, all wet weather samples showed significant elevation in values as compared to the May baseflow results. Stations 1, 2 and 3 had the highest values for most parameters. For example, wet weather total phosphorus at station 2 was seven times higher than the baseflow value. Figures 7, 8, and 9 show comparisons between baseflow and wet weather sample results for the watershed pollutants of concern, Total Phosphorus, Total Suspended Solids and Ecoli at all stations. Appendix A provides full results from all watershed sampling.

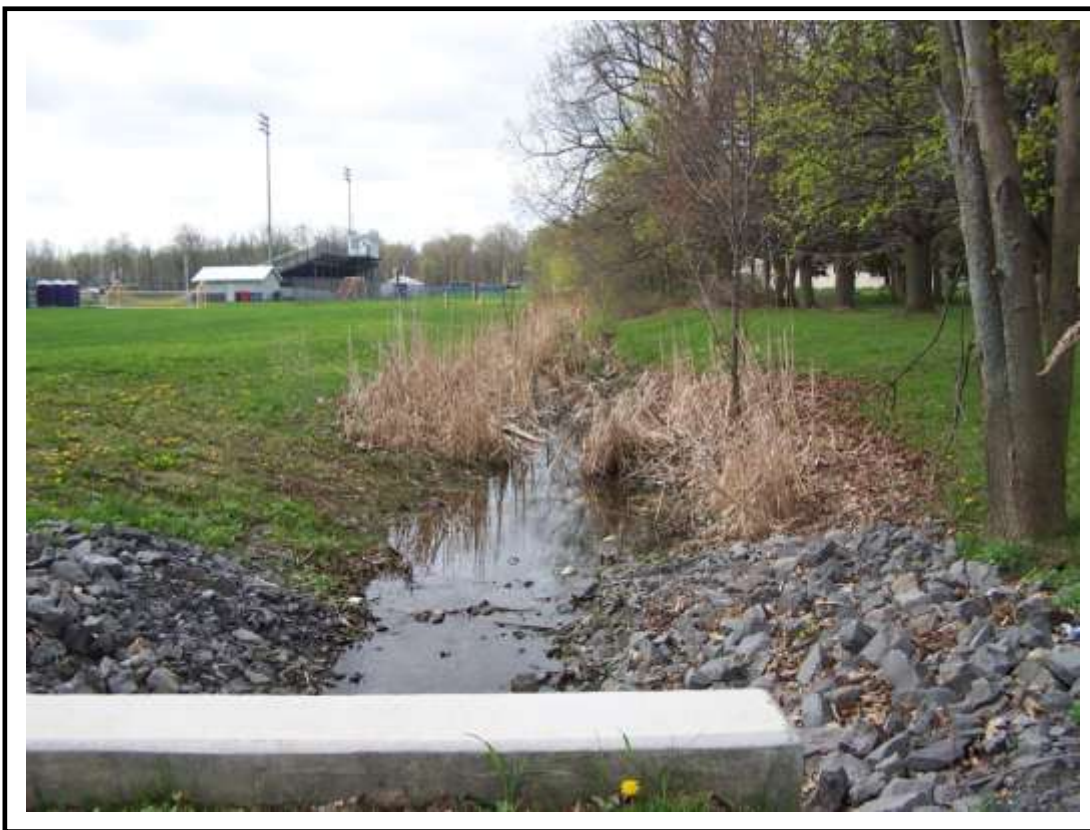
Figure 13. Impacted Buffer at Webster Schroeder High School with High Restoration Potential

Each assessed reach was given a score for reforestation potential ranging from 1-5. A score of 5 indicated that the impacted area was on public land where the riparian area does not appear to be used for any specific purpose with plenty of area available for planting. A score of 1 indicated limited restoration potential with the impacted area on private land where road, building encroachment or other features significantly limit available area for planting. There were 25 impacted reaches identified with 16 having scores of 3-5 (greatest potential for restoration). Figure 13 shows an impacted buffer in subwatershed C.

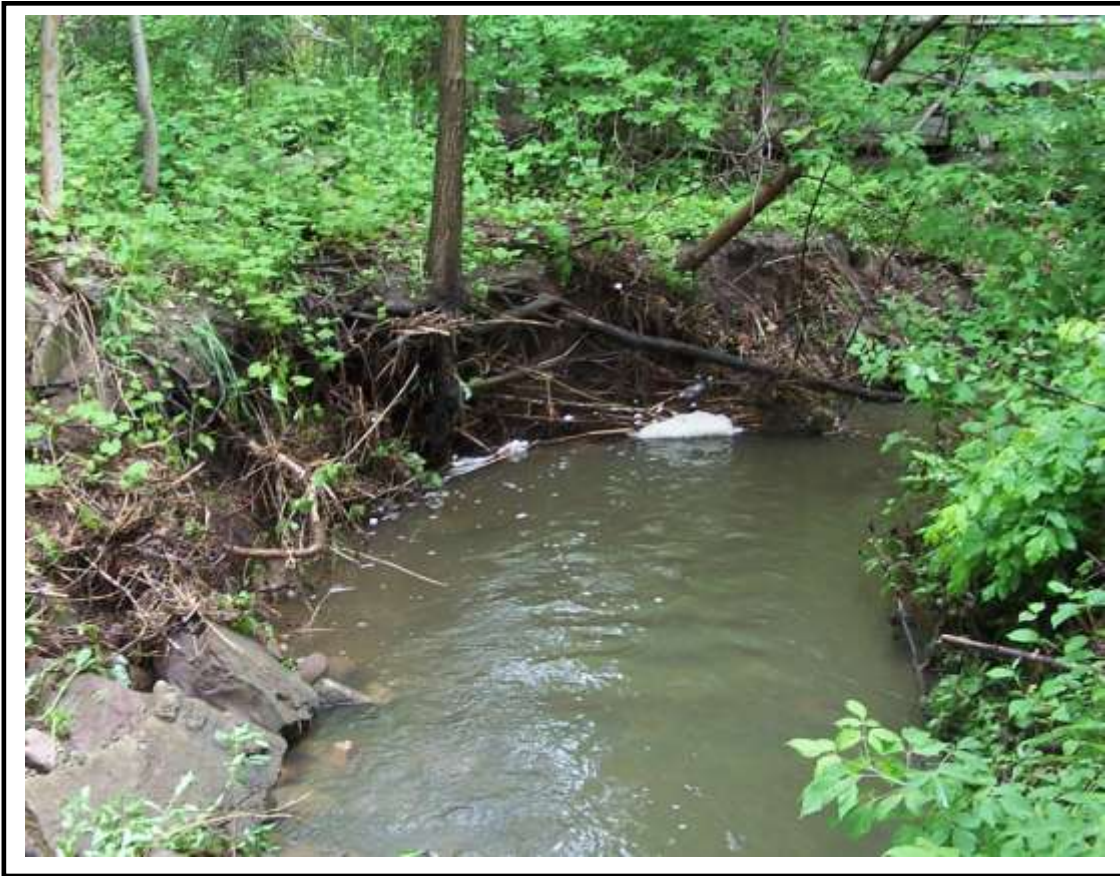
Figure 14. Active Stream Bank Erosion in Subwatershed C

Erosion severity was measured on a scale from 1-5 with a score of 5 indicating active downcutting, tall banks on both sides of the stream, eroding at a fast rate with erosion contributing a significant amount of sediment to the stream, or an obvious threat to property or infrastructure. Only 23 of the 42 erosion sites were ranked as suitable for restoration due to available access to the sites. Of the 23 suitable for restoration, 19 had a severity score of 3 or higher making them priority candidates for restoration/stabilization. Figure 14 shows an example of active stream bank erosion in subwatershed C.

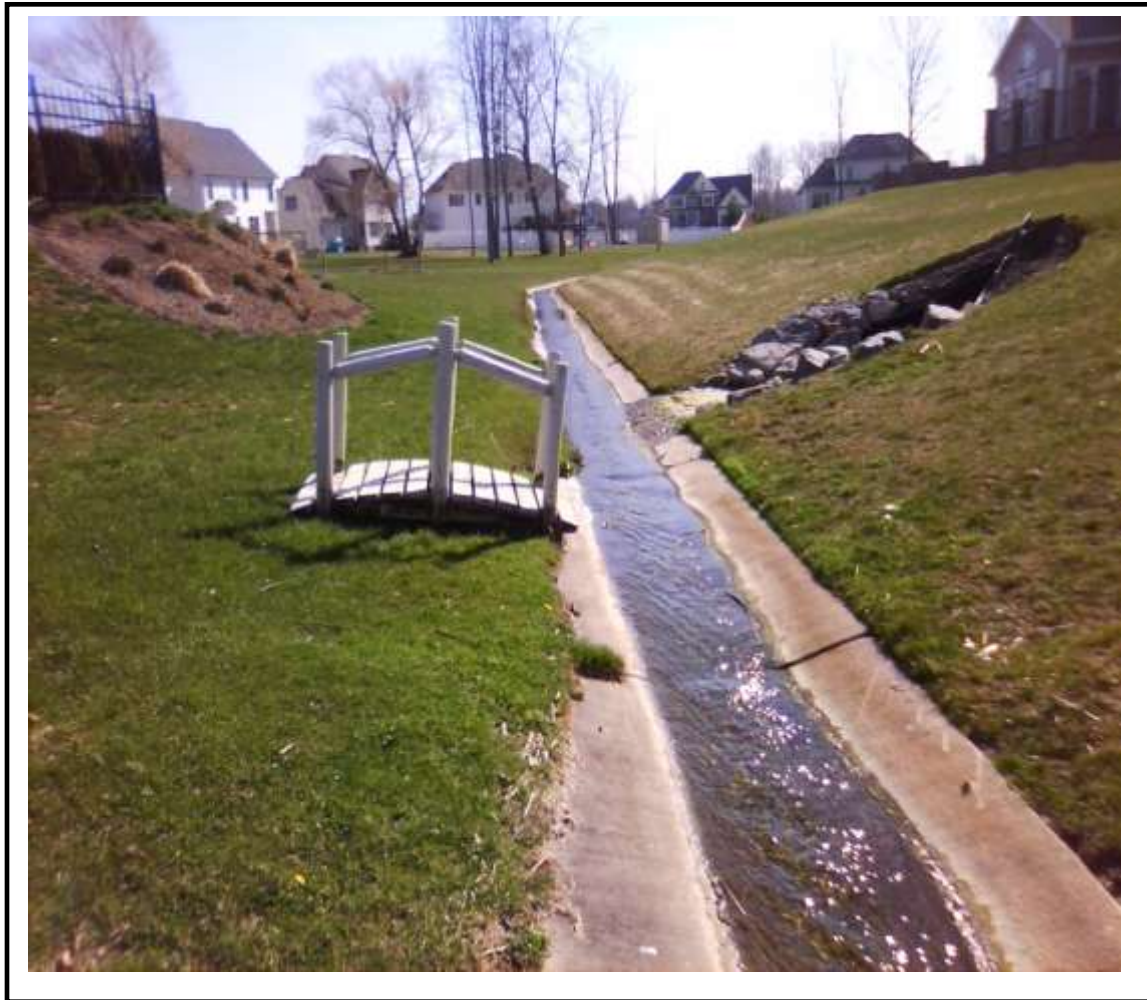
Figure 15: Channelized Stream Segment in Subwatershed E with Severity Score of 5

As with erosion and buffers, channel modification was measured for severity and restoration potential. The highest level of severity indicates a long section (>500 ft) with very shallow channel water and no natural sediments present in the channel. Figure 15 is an example of a stream reach on Shipbuilders with a severity

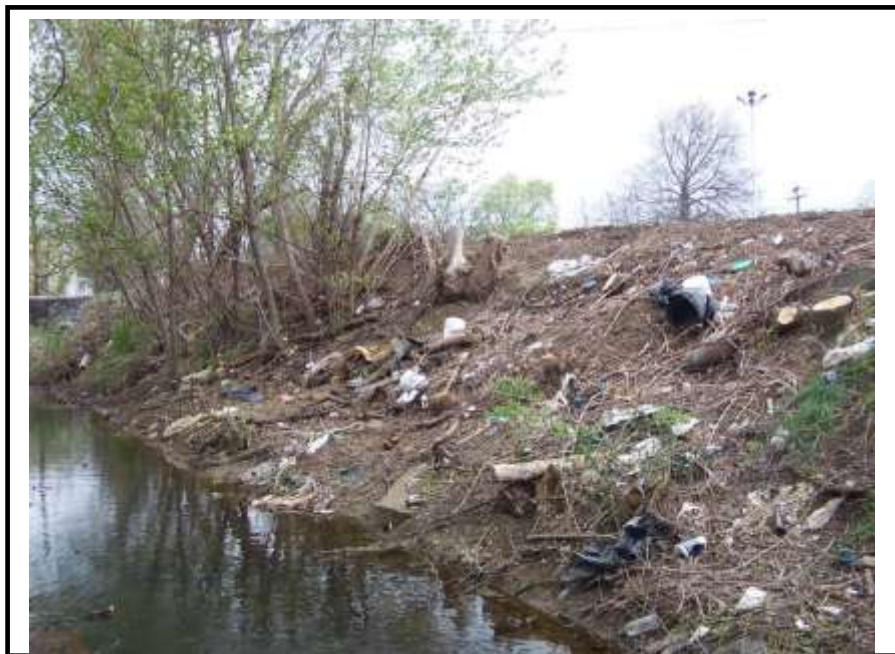
Figure 16. Trash and Debris in Subwatershed D

Six locations were identified as trash and debris hotspots. Materials found ranged from yard waste, pet waste, paper, plastic and automotive products. All locations have high potential for restoration by volunteer clean-ups, education, or removal by municipal staff. Figure 16 shows a trash hotspot in a commercial area of subwatershed D.

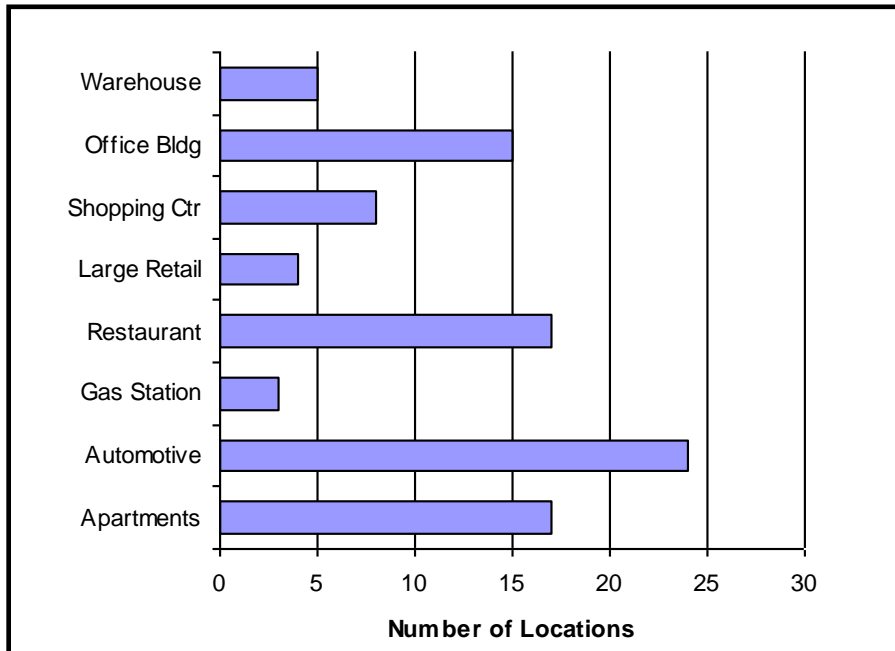
Figure 19: Shipbuilders Creek Watershed Hotspot Types

Commercial hotspots typically experience a great deal of vehicle inputs, generate waste of wash water, handle fuel or repair vehicles, or store products outside. Each type of commercial hotspot can generate its own blend of pollutants which can include nutrients, hydrocarbons, metals, trash or pesticides (CWP, 2005). Figure 19 gives a further breakdown of hotspot types in the SC watershed based on the specific property class description. Figure 20 illustrates a used cooking grease storage bin that has spilled on the ground located less than 20 feet from the stream.

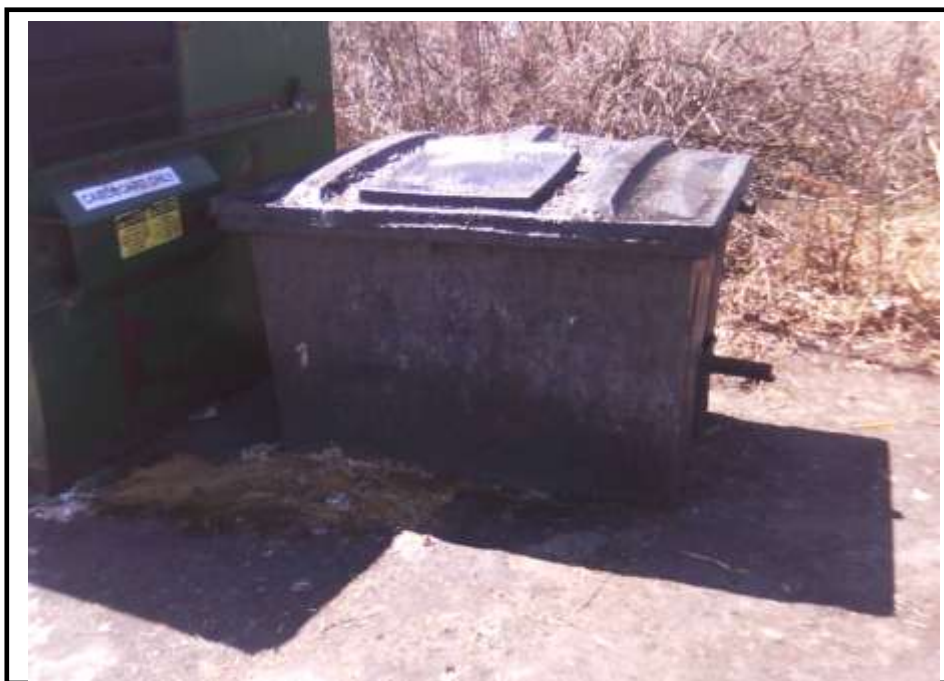
Figure 20: Grease dumpster spill in subwatershed D

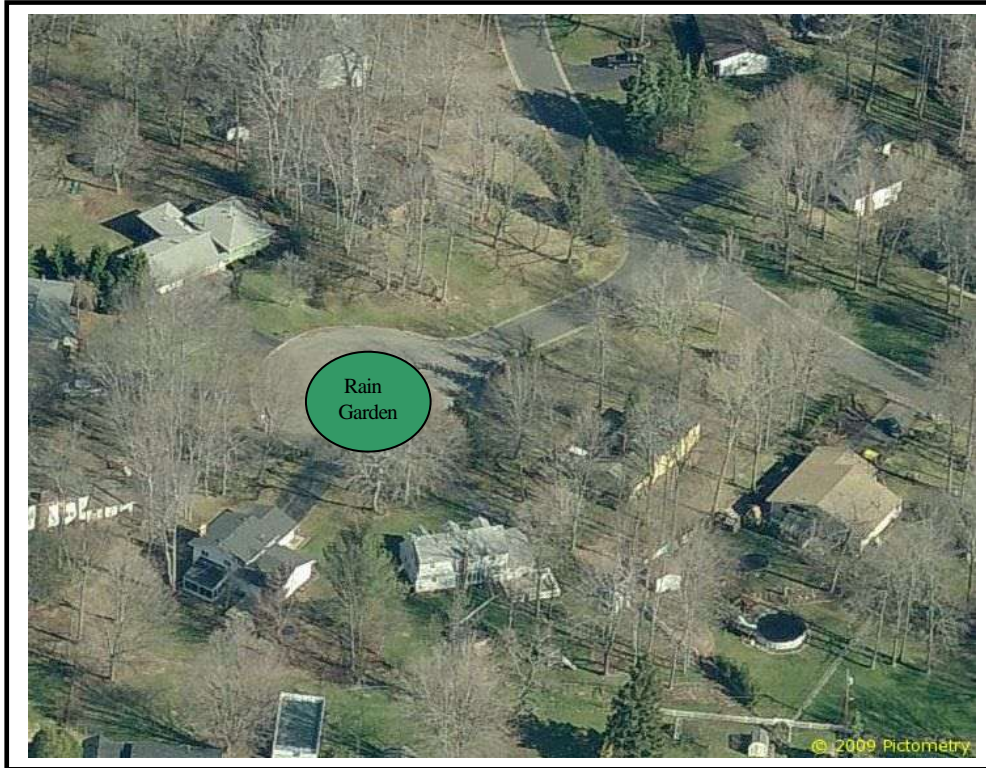
Figure 23: Proposed Cul-de-sac Rain Garden (Ironwood Cir/Sequoia Dr.)

Figures 23 – 25 are examples of potential green infrastructure practices that could be installed in the Shipbuilders Creek watershed. For further details and examples of these practices, see Appendix I.

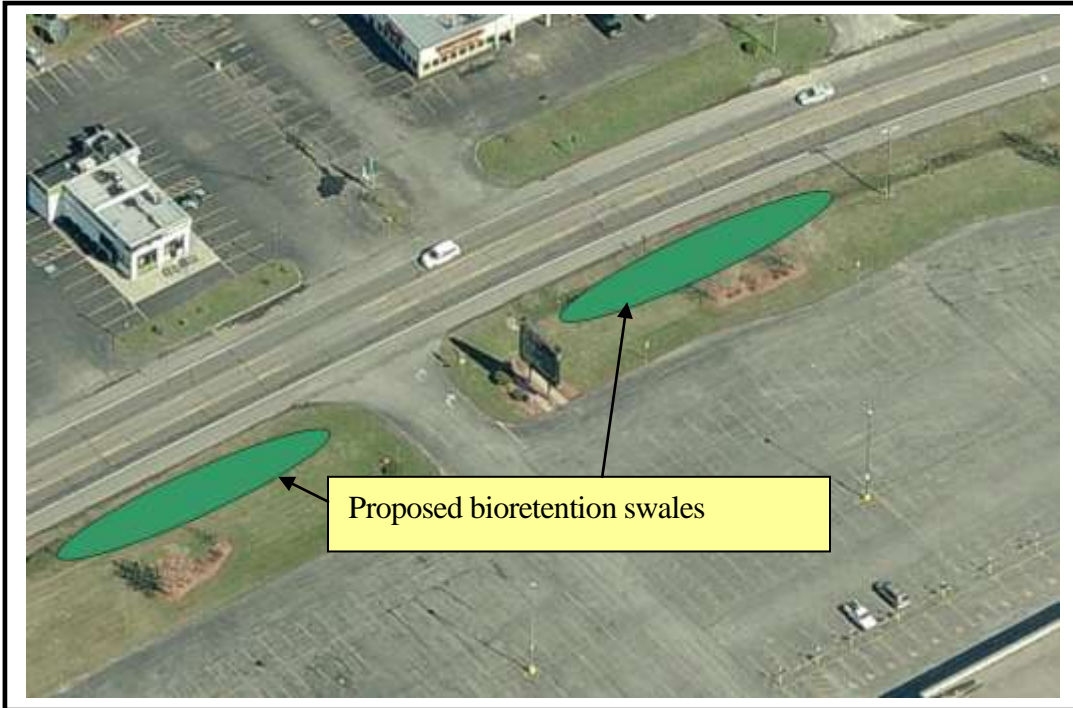
Figure 24: Proposed Vegetated Bioretention Swale at Lowes Theatre

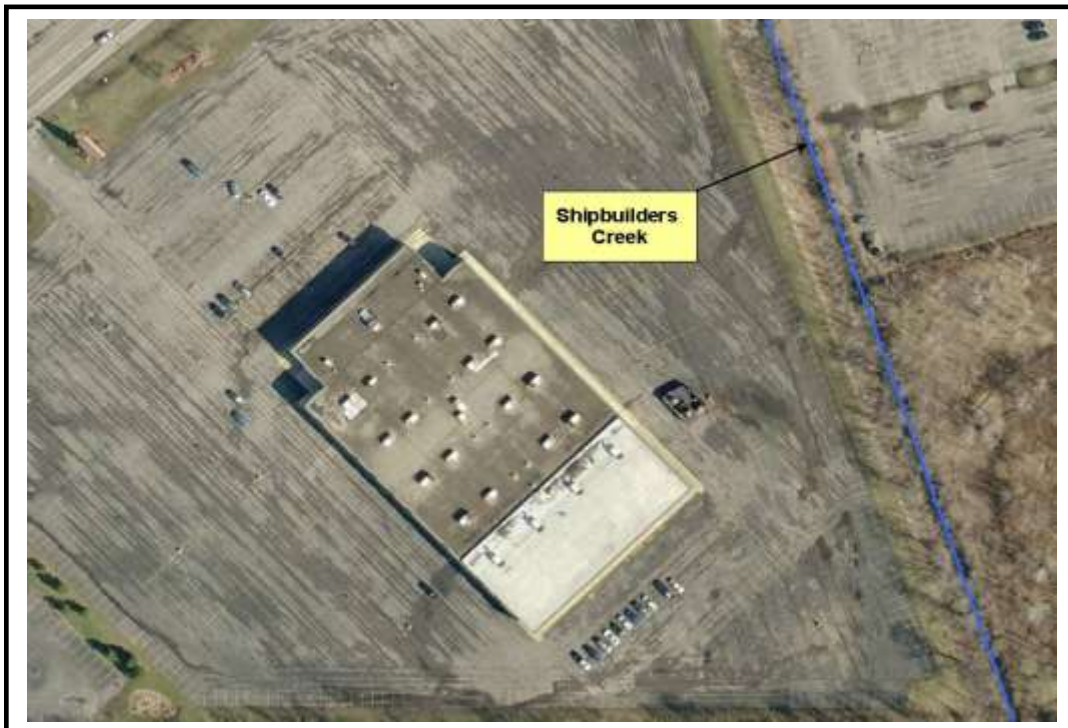
Figure 25: Proposed Impervious Cover Reduction at Lowes Theatre

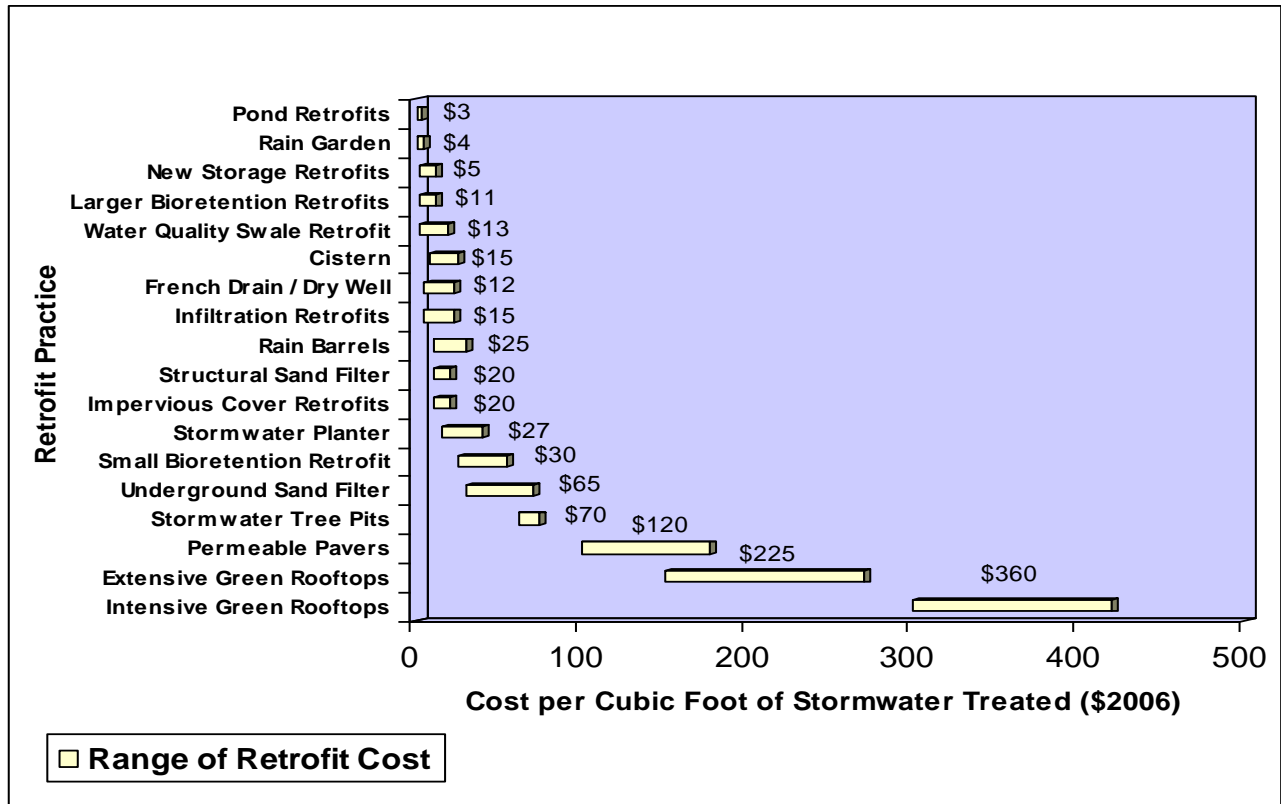
Figure 26. Range of Stormwater Retrofit Costs (Center for Watershed Protection)

1. Highly cost effective projects were those ranging from \$1 to \$11 and were given three points.
2. Median cost effective projects were those ranging from \$12 to \$25 and were given two points.
3. Low cost effective projects were those ranging from \$26 and \$100 and were given one point.
4. All other project types were not ranked – excluding for example green roofs.
